Hudson River Historic District
New York: Dutchess and Columbia Counties

Property Name : Ellerslie (see: 576327 et al)

Location : 243 Morton Rd.; east side; south of Rhinecliff.

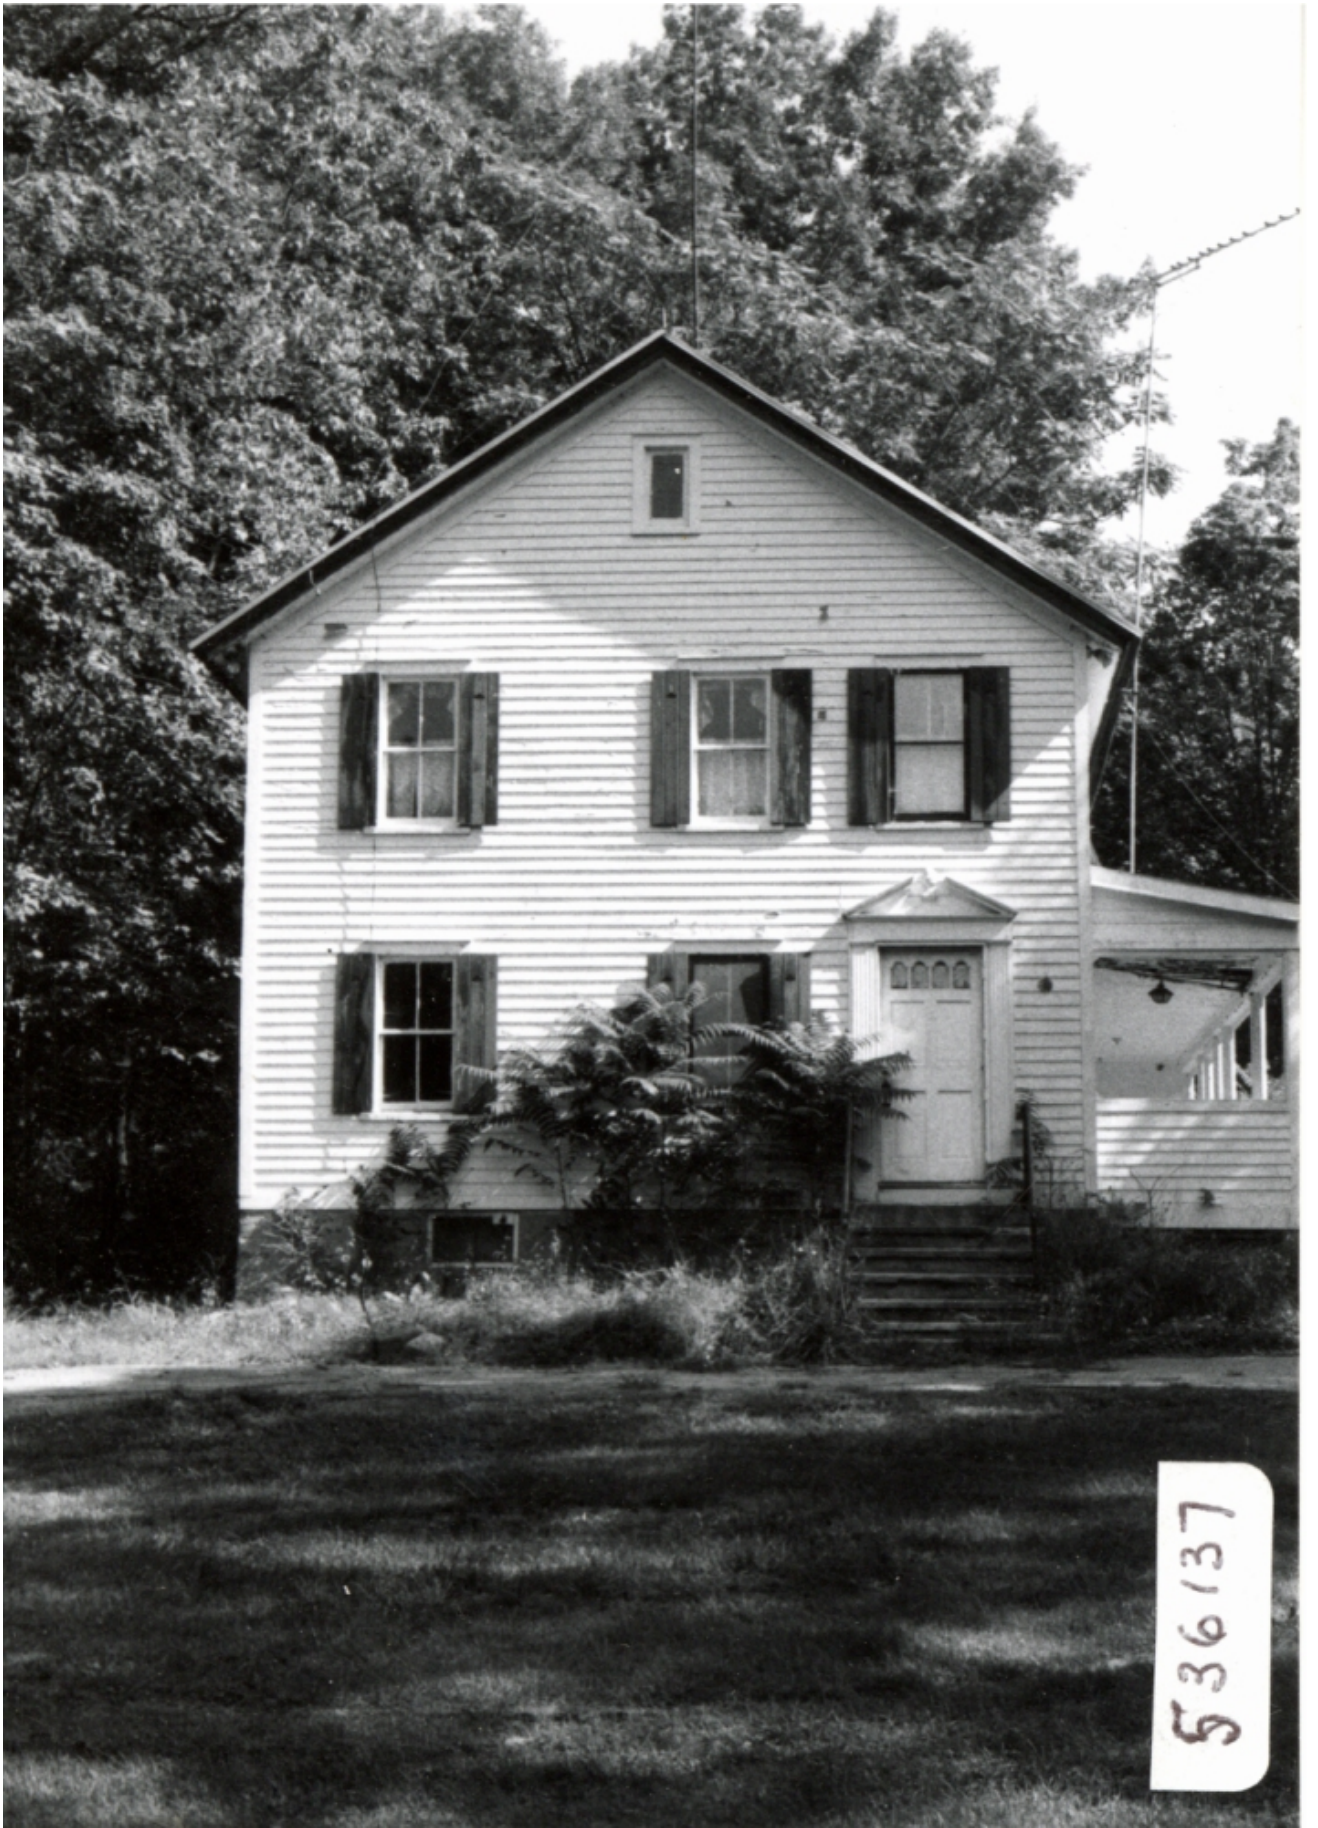
536137

Description: The two story, gable front frame residence with three-ranked facade and side hall entry includes a rectangular plan. The house features: clapboard, a stone and brick foundation, 2/2 double hung sash windows with flat casings, crowns and replacement shutters. The fenestration on the front elevation is slightly irregular; the four-panel front door with four-lights is enframed by a Colonial Revival surround with broken pediment and flanking fluted pilasters. The south side elevation includes a verandah with shed roof and chamfered posts and clapboarded railing. The house is surmounted by a standing seam metal roof with fascia, boxed eaves and frieze.
