BUILDING-STRUCTURE INVENTORY FORM

- 1. BUILDING NAME(S): J. W. Moore House (Individual Component #21)
- 2. COUNTY: Dutchess TOWN/VILLAGE: Rhinebeck VILLAGE: NA; Rhinebeck vic.
- 3. STREET LOCATION: Mill Road
- 4. OWNERSHIP: a. public b. private
- 5. PRESENT OWNER: Clem Morgello ADDRESS: Box 19, RD 2, Rhinebeck, 12572
- 6. USE: Original: residence Present: residence
- 7. ACCESSIBILITY TO PUBLIC: Exterior visible from public road: Yes No
Interior accessible: Explain no; private residence

RHINEBECK MULTIPLE RESOURCE AREA, DUTCHESS COUNTY, NEW YORK

BUILDING NAME: J.W. Moore House; Individual Component #21

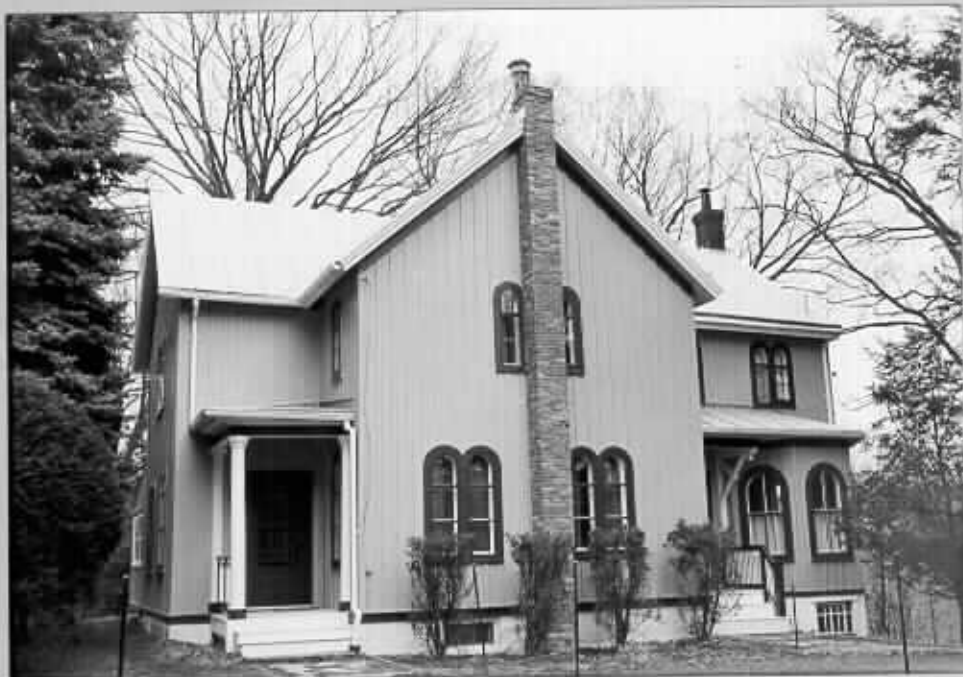
1 South facade

The front facade is oriented southward and away from Mill Road to the west. The facade features a projecting central pavilion with symmetrically placed, rounded-arch windows. A

The primary entrance is located in the recessed western bay on the south facade. The doorway is surrounded by simple wooden trim and sheltered under a simple, flat-roofed entrance porch supported by polygonal columns. A secondary entrance is located in the recessed eastern bay on the south facade. It is sheltered by a broad, hip-roofed entrance porch which extends to share a common roof across the tripartite projecting bay window. A turned balustrade and a large, decorative bracket with diagonal braces and a turned pendant embellish the porch.

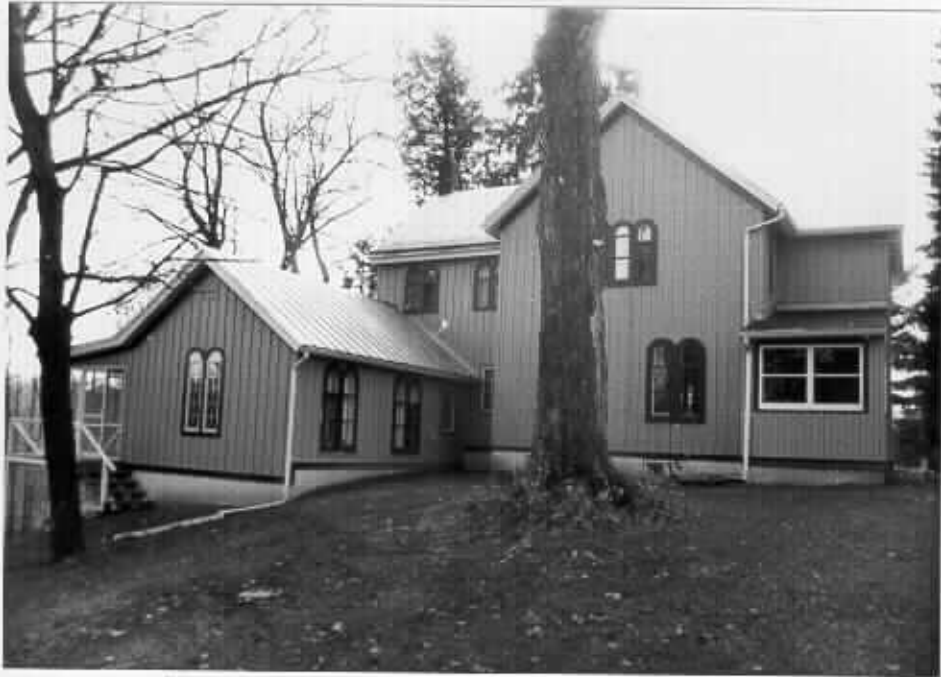
2 North & west elevations

The west (road-side) elevation features two sets of paired, rounded-arch windows on the first story and a tripartite group of rounded-arch windows at the upper story. A modern, one-story, shed-roofed addition is attached to the north end of the west elevation, nestled within the interior angle of the west and north legs of the cruciform. The north elevation, like the west elevation, features paired, rounded-arch windows and a tripartite unit of rounded-arch windows.

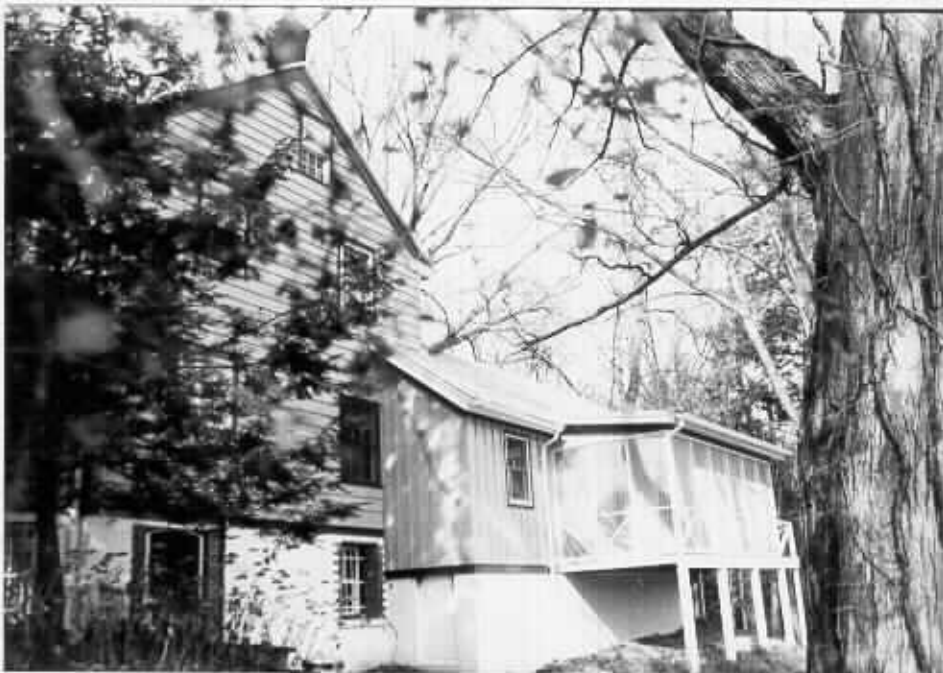
3. East (side) elevation

The east elevation is characterized by a variety of irregularly placed, six-over-six, double-hung sash windows with simple wooden trim. The fully exposed basement level features a service entrance and deeply recessed window, both with brick surrounds. A modern, non-contributing one-story frame wing (ca. 1984) is attached perpendicularly to the northeast corner of the east leg of the cruciform. The wing is surmounted by a sweeping gable roof which projects to cover the porch across the east facade.

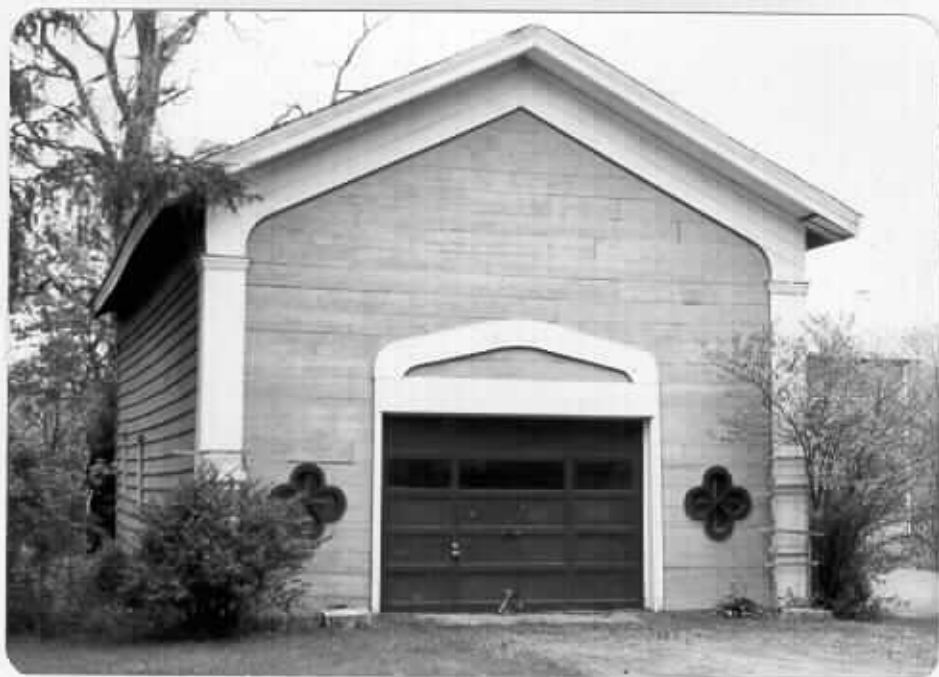
4 Carriage house, north and east (front) elevations

The carriage house (ca. late-1860s) is a rectangular frame building sheathed with flush board horizontal siding and clapboard

siding. The picturesque building is ornamented with quatrefoil windows and a large, decorative, miter-arched lintel above the centrally placed carriage entrance (currently containing a modern garage door) on the front (west) gable end. Broad corner pilasters supporting a wide frieze accentuate the front facade.

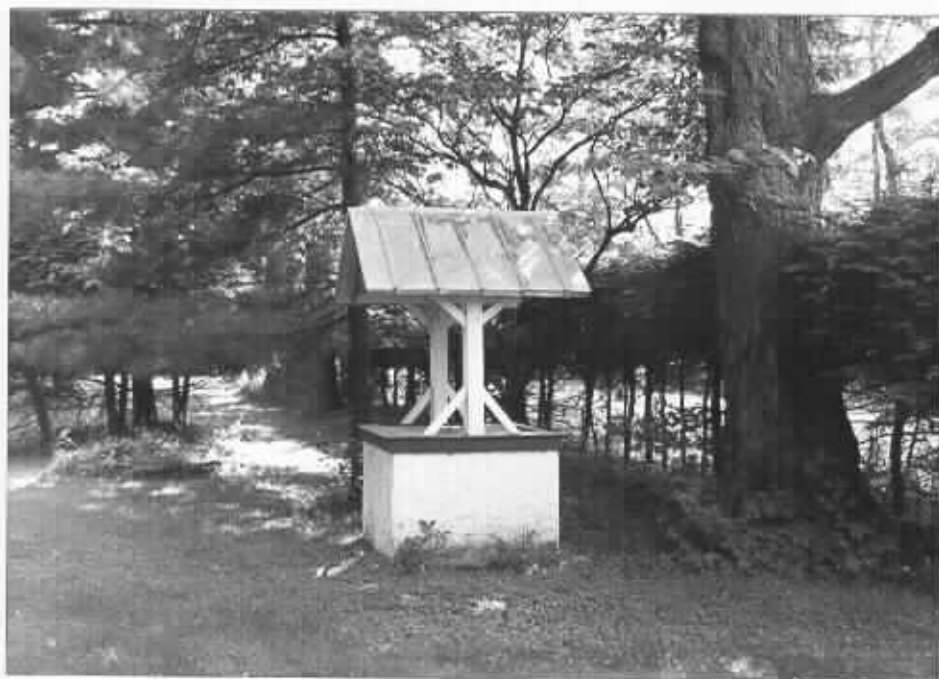
5 Well house, viewed from north

The well, a deep, dry-laid stone structure, and wellhouse are located on the front yard. The wellhouse is composed of a square, stone base surmounted by bracketed frame posts supporting a standing-seam metal gable roof. The well and wellhouse are believed to date from the nineteenth century.

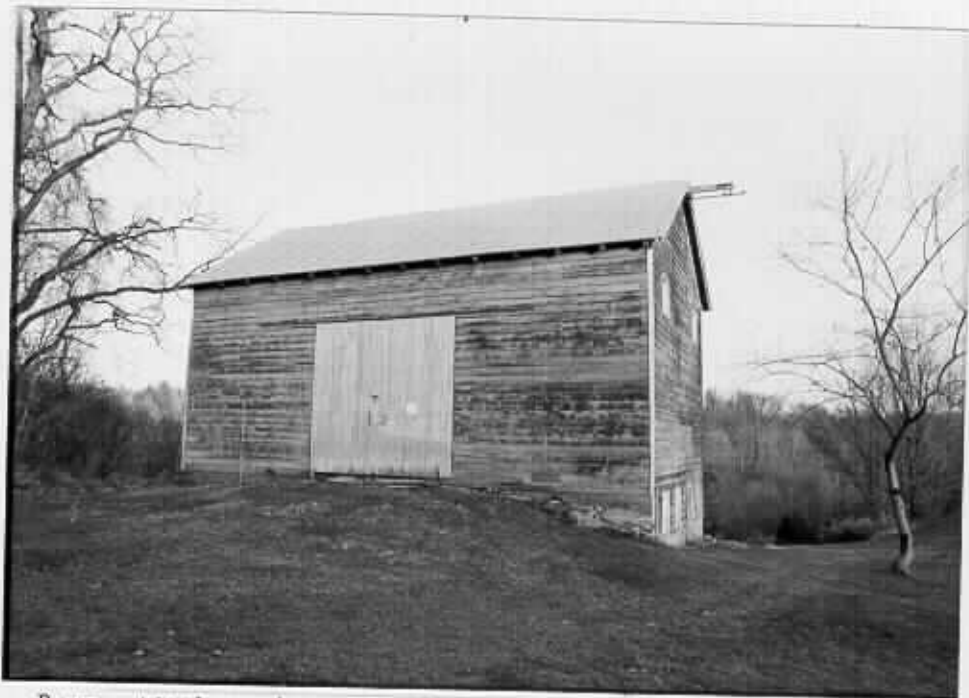
6 Barn, west and south elevations, viewed from west

There are two contributing outbuildings (barn and carriage house), two contributing support structures (well/wellhouse and corn crib) and one modern, non-contributing structure (in-ground pool). The barn, embanked into the steeply sloping hillside, is a large, rectangular frame building with a standing-seam metal gable roof with exposed rafters under the projecting eaves. The barn is sheathed with flush board horizontal siding and features a large, centrally placed wagon door on the front (west) facade. It is believed to date from the mid- to late nineteenth century.

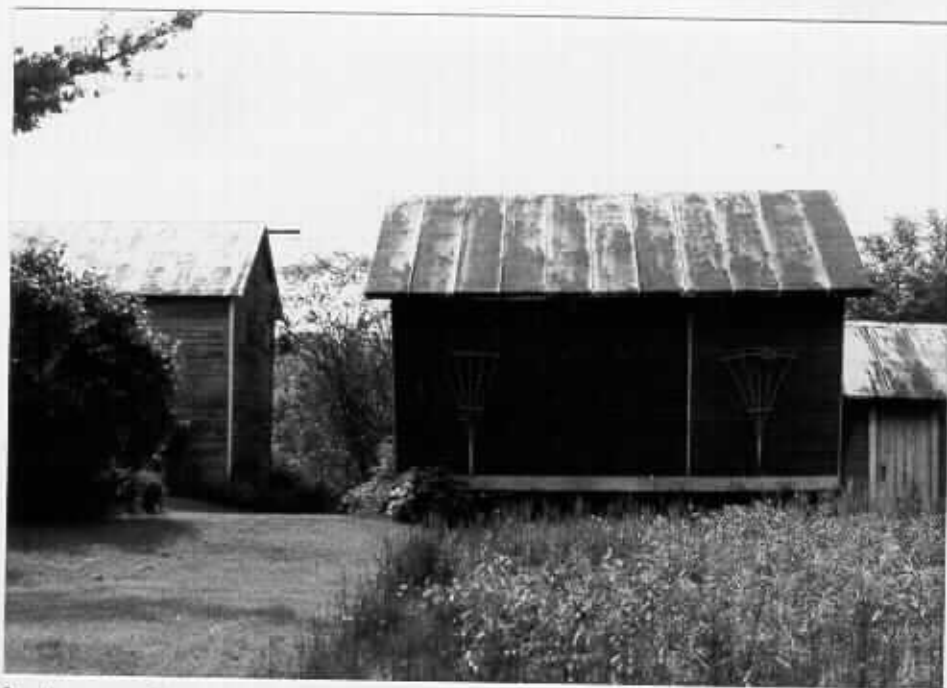
7. Corn crib and shed, west elevation

The corn crib is a relatively large, rectangular frame structure with slatted siding and a standing-seam metal roof. A small, gable-roofed frame shed and glass-enclosed greenhouse are attached to the south end of the corn crib. The group is believed to date from the late nineteenth century.
